## TECHNICAL BULLETIN

**MODIFICATION PROCEDURES  
FOR  
FLIGHT COORDINATION CENTRAL  
AN/TSC-61B  
(NSN 5895-01-057-3968) (EIC: JP4)  
TO INCORPORATE  
SINGARS RADIOS**

**15 MAY 1993**

Technical Bulletin  
 No. 11-5895-469-30

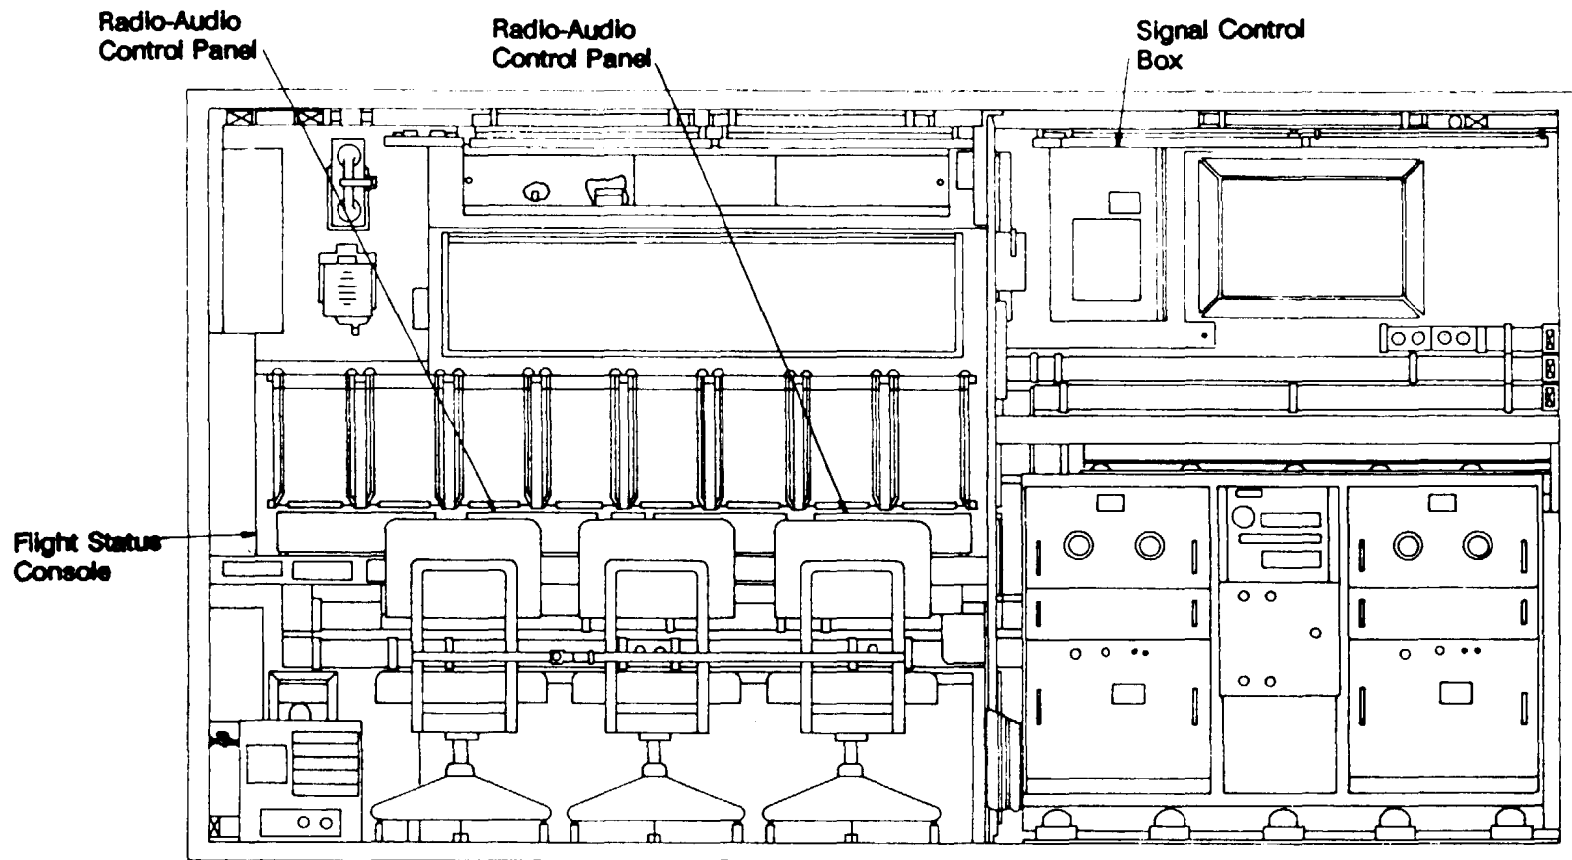
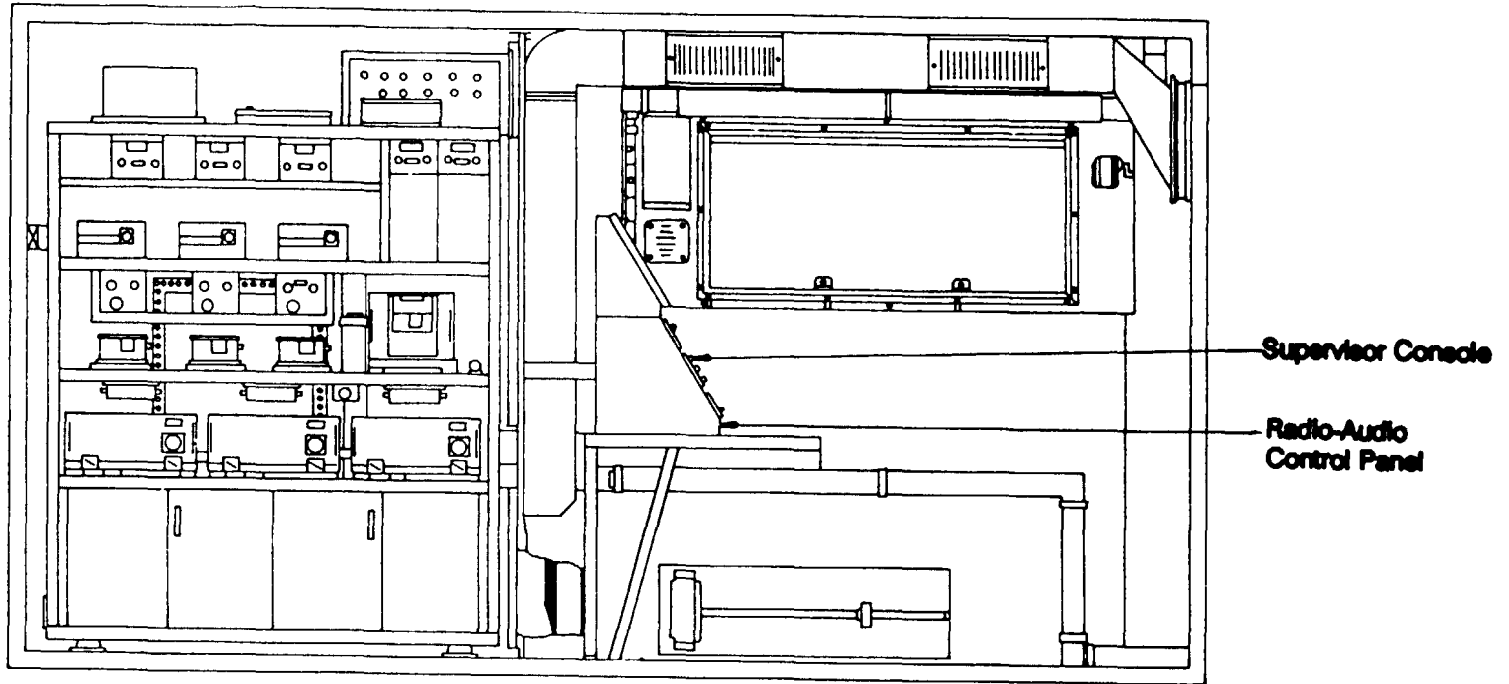
Figure 1. AN/TSC-61B (Sheet 1 of 2)

The Radio Audio Control Panel C-10417/TS (Part Number SC-B-881153) (3 ea) and the Signal Control Box assembly (Part Number SC-D-881184) (1 ea) will be modified and their locations are illustrated in figure 1.

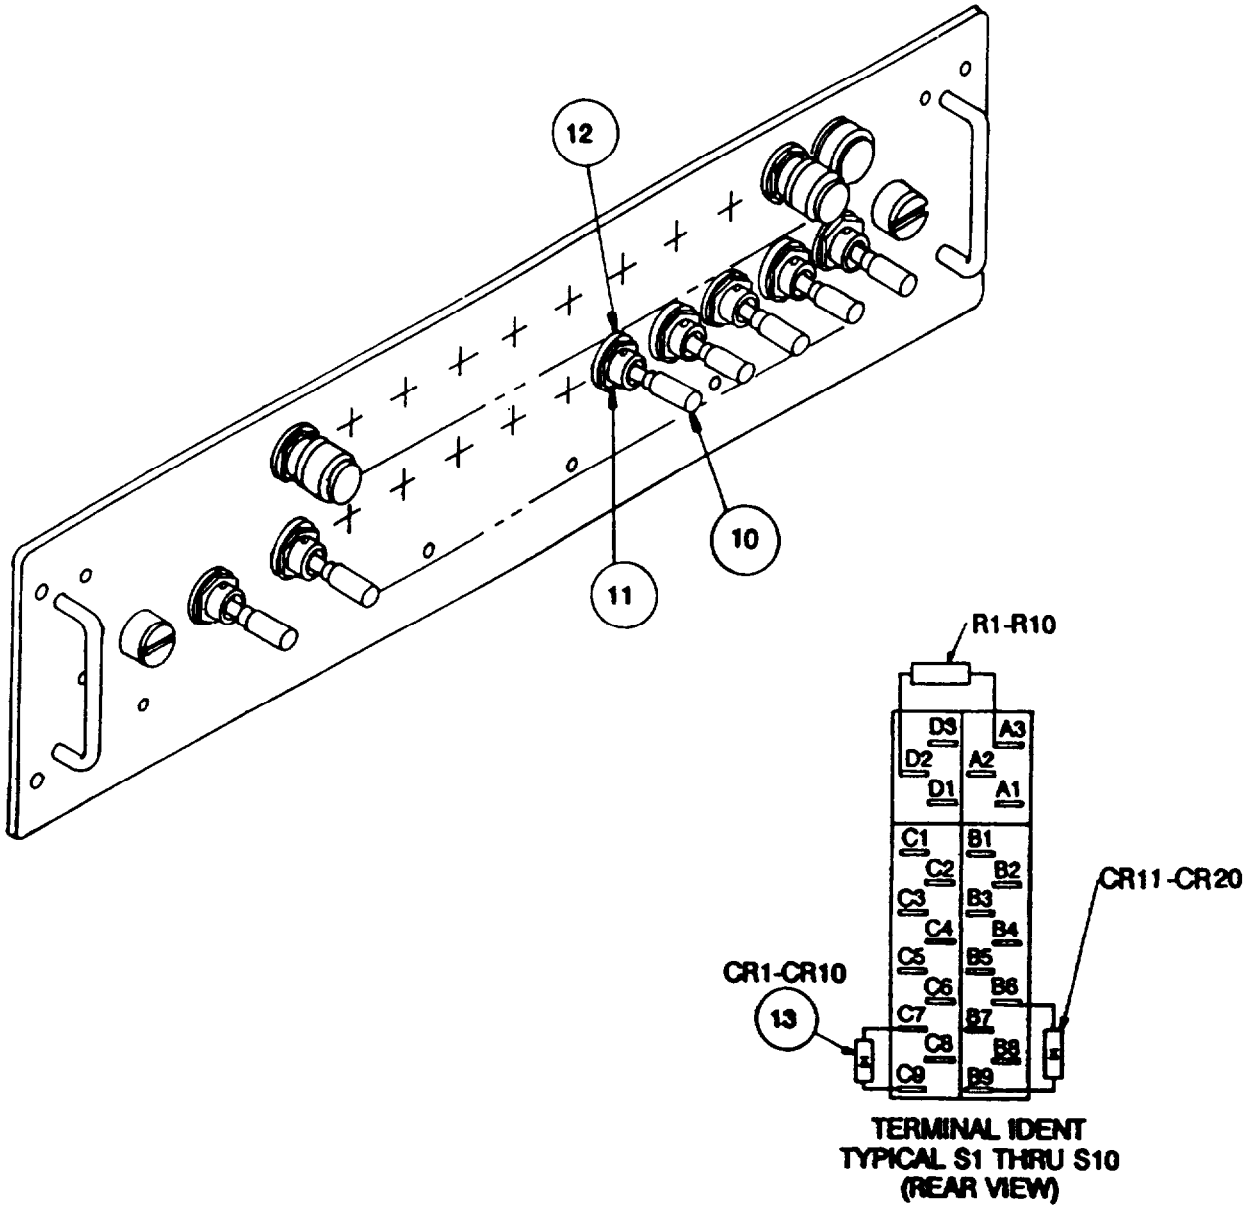
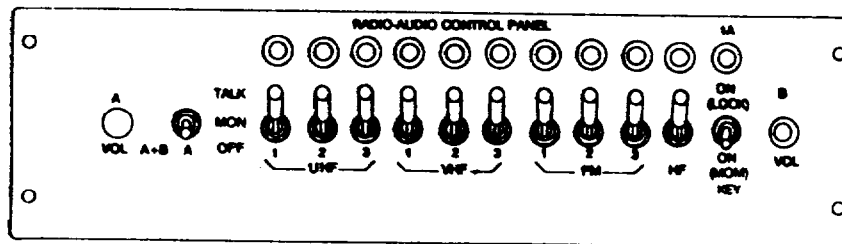
Figure 3. Panel Assembly (SC-D-881528)

8. Identify diode CR1 (13) which is connected to Pins C7 and C9 contacts of the FM1 switch (11) with wires color coded violet and yellow.
9. Remove the body of diode CR1 (13) by cutting with a pair of diagonal pliers.

4. Unscrew the four cross-tip screws (8) from the top cover (9) and lift the cover out of the way.
5. Remove front panel knob (10) from the FM1 switch (11) by turning the knob counterclockwise. (see Figure 3)

6. Remove lock nut (12) from the FM1 switch (11) with adjustable wrench.
7. Push the FM1 switch (11) back through the mounting hole and lift and rotate the switch to locate diode CR1 (13) to be removed.

10. Connect the remaining pigtailed of diode CR1 (13) together with a pair of long nose pliers.
11. Solder the pigtailed together.
12. Reinstall the FM1 switch (11) by rotating the switch back to its original position and pushing it through the front mounting hole.

13. Replace the lock nut (12) on the FM1 switch (11) and tighten with adjustable wrench.
14. Replace the knob (10) on the FM1 switch (11) by turning clockwise.

17. Change the part number from SC-B-881153 to SC-B-881153-1 on the Radio-Audio Control Panel (7) and Part Number SC-D-881528 to SC-D-881528-1 on Panel Assembly.
